# Seismic Performance of Reinforced Cantilever Columns in Earthquake Environments through Nano-GFRP Retrofitting

S. Venkatachalam<sup>\*</sup>, K. Vishnuvardhan, V. Sampathkumar, S. S. Sugandhan,  
M. Rubakkumar and N. K. Surya

Department of Civil Engineering, Kongu Engineering College, Perundurai, TN, India  
Received: 29.06.2024 Accepted: 25.09.2024 Published: 30.12.2024

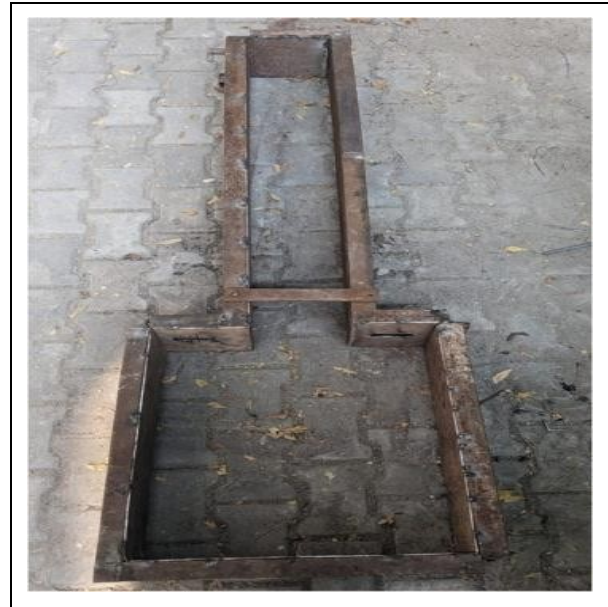
**Fig. 2: Mould for specimen**

The test program consisted of three RC columns categorized into three numbers. The column has a cross-section of 180 mm × 180 mm with a length of 1200 mm. The column has its end fixed with stub support of 480 mm width and 630 mm height, as mentioned in Fig. 1. The specimens are cast using the steel mould, as shown in Fig. 2. The dimensions of the mould are the same as the specimen.

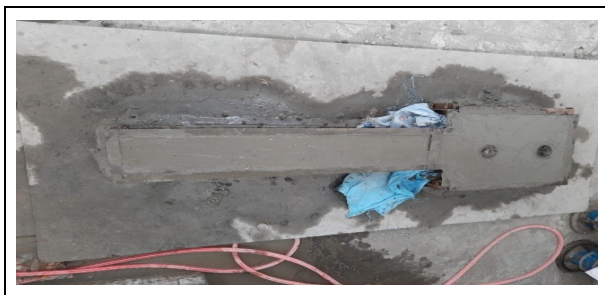
Fig. 5: Cast specimen

The specimens were cast with column formwork using a ready-mixed concrete design with Portland cement, a maximum aggregate size of 20 mm, a prescribed slump of 100 mm, and a nominal compressive strength of 20 MPa. First, the stub was filled with concrete and compressed using vibrators. Afterward, the columns were cast and fully vibrated (Fig. 5). Plastic sheets were used to cover the exposed surfaces of the specimens. Additionally, three 150 × 150 mm cubes were cast alongside the column specimens to monitor the concrete's strength development over time. A water-to-cement ratio (w/c) of 0.50 was employed to ensure sufficient workability. The average compressive strength reached 13 MPa after 7 days and 18 MPa after 14 days, which is consistent with the expected concrete values.

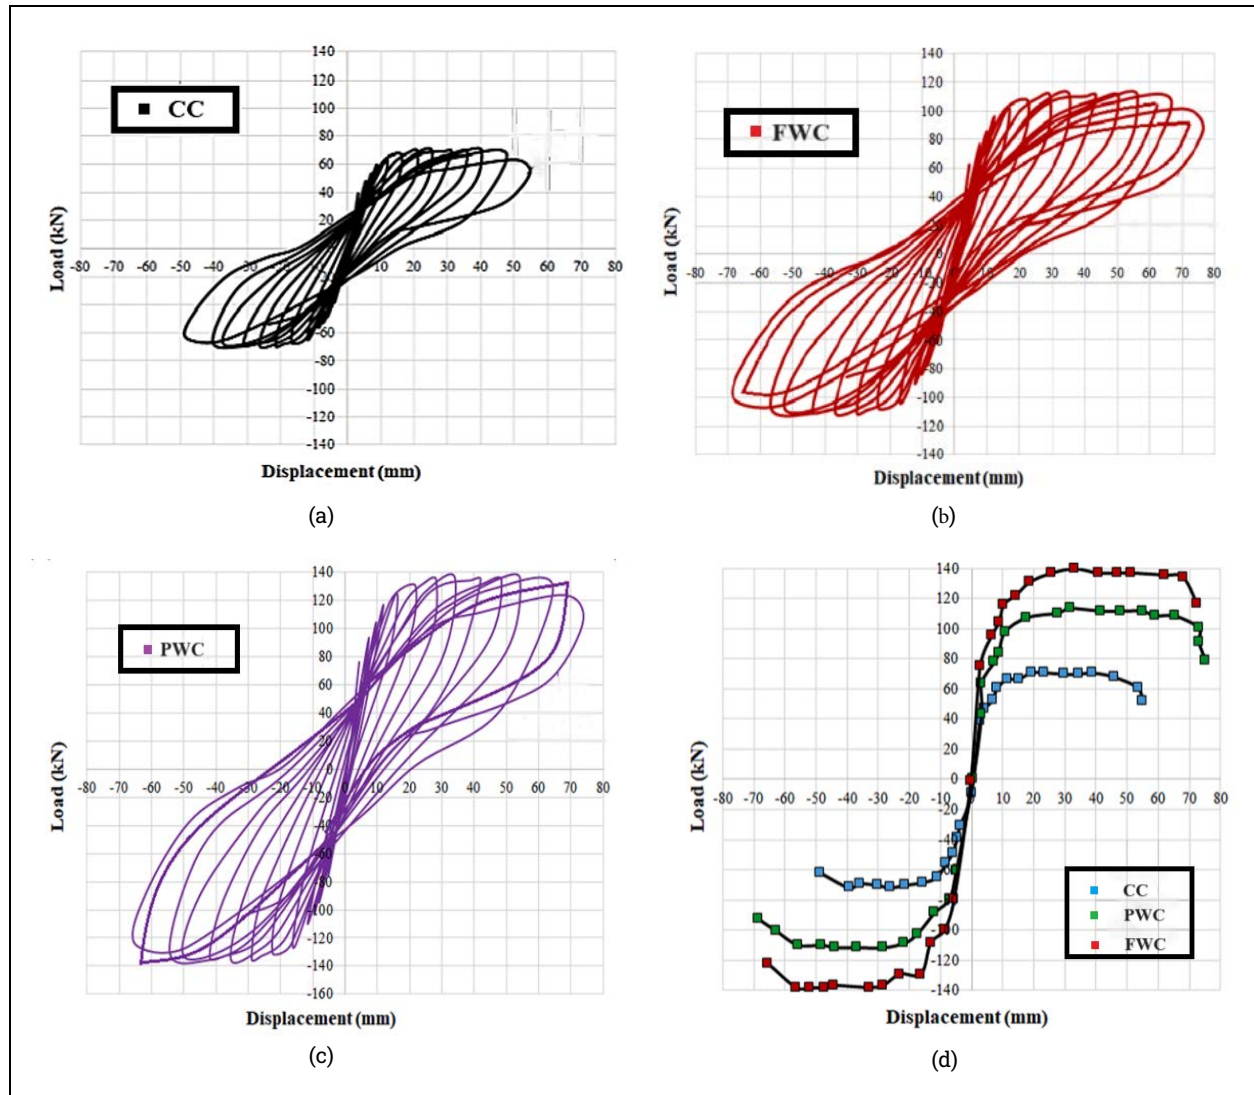
Fig. 8: (a, b, c) shows the hysteresis curve of specimens, and (d) shows the load-displacement curve of columns

The process of energy absorption is essential for reducing the seismic force acting on columns. When examining the hysteretic behavior of RC structural components, a key characteristic to consider is their energy dissipation capacity. In the event of an earthquake, RC structural elements lacking sufficient energy dissipation capacity are susceptible to significant displacements and may even collapse as a result of the cumulative energy lost from minor deformations. The energy dissipation inside the cycle is represented by the area enclosed within the hysteretic loops of the load-displacement curve for the specimens. Fig. 7 shows the absorbed energy content of the specimens. Hysteretic loops open in response to additional load, causing the enclosed area to increase rapidly, thereby improving the capacity to dissipate energy. However, GFRP has a stronger impact on this factor. Retrofitting square RC columns with GFRP wraps results in substantial improvements in seismic performance compared to conventional, unreinforced columns. The retrofitting enhances lateral strength by 96%, significantly increases ductility (26.1% to 74.1% depending on comparison), and boosts energy absorption capacity by up to 130%. As seen in Table 4 and Fig. 8, the energy absorption value of the original specimens is increased by GFRP textiles.

of cycles increase, the stiffness of the columns gradually decreases. The stiffness of the columns strengthened with GFRP also reduces with an increase in the number of cycles. The transverse rebars improve the core concrete
